NOTTAWASAGA VALLEY CONSERVATION REPORT

WATER

MINISTRY OF NATURAL RESOURCES

CONSERVATION AUTHORITIES BRANCH

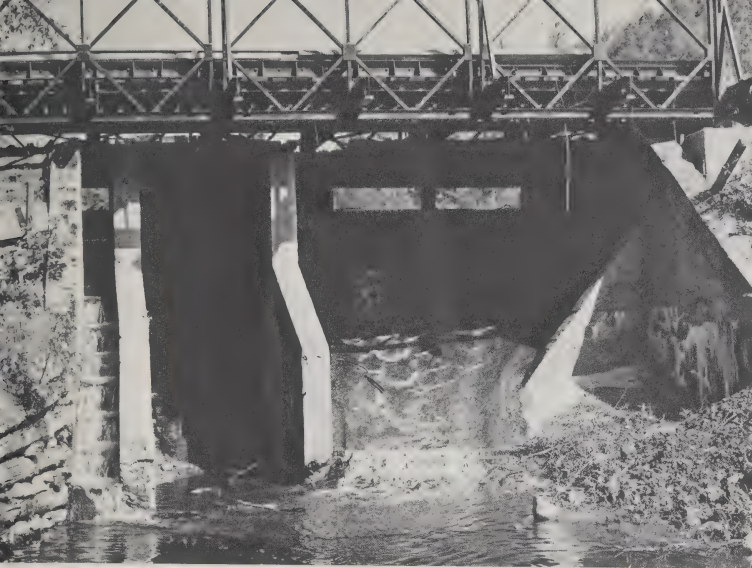
Downstream view of dam spillway on the Boyne River, Mulmur Township. Fish ladders in these structures would encourage fish migration.

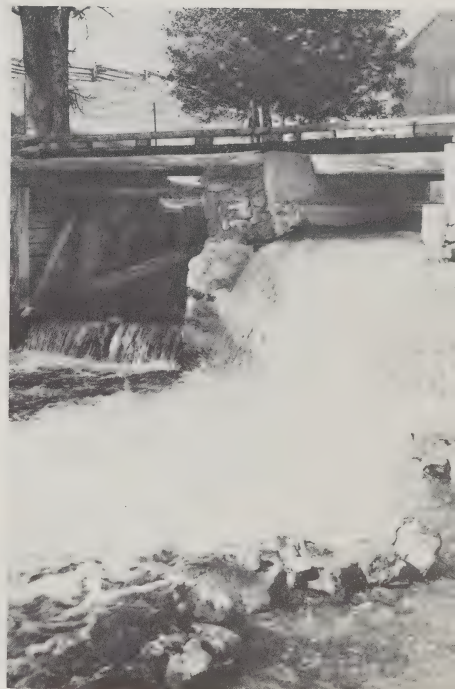
Downstream view of dam on the Mad River at Singhampton. Such privately owned dams could be advantageously incorporated into a flood-warning system.

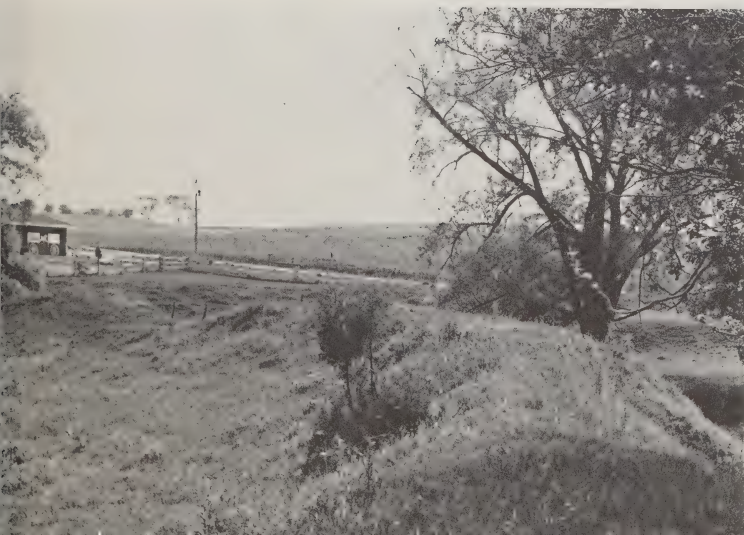
Remains of a former dam on Bailey Creek near Keenansville. A new dam and reservoir just upstream from this site would provide additional summer flow as well as recreational facilities.

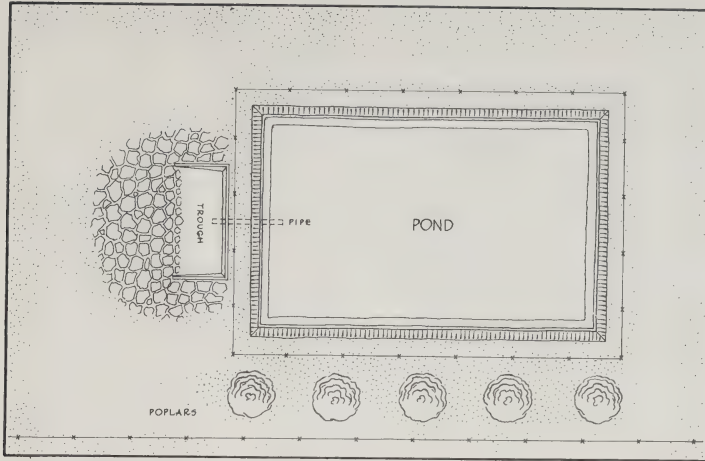
PLAN OF DUG-OUT POND

SECTION OF DUG-OUT POND

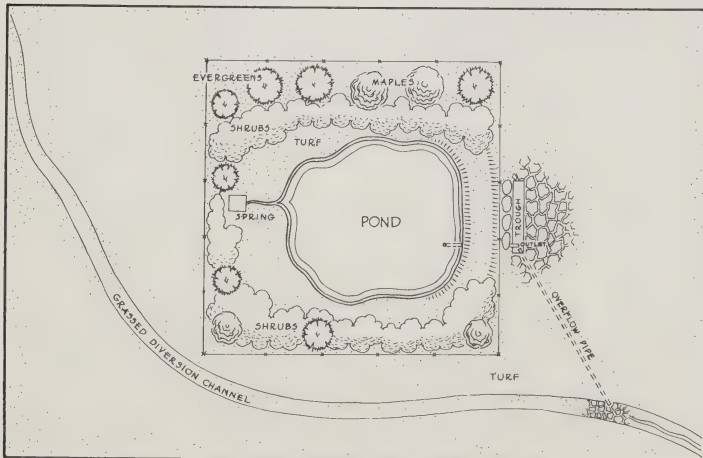
PLAN OF SPRING-FED POND

SECTION OF SPRING-FED POND

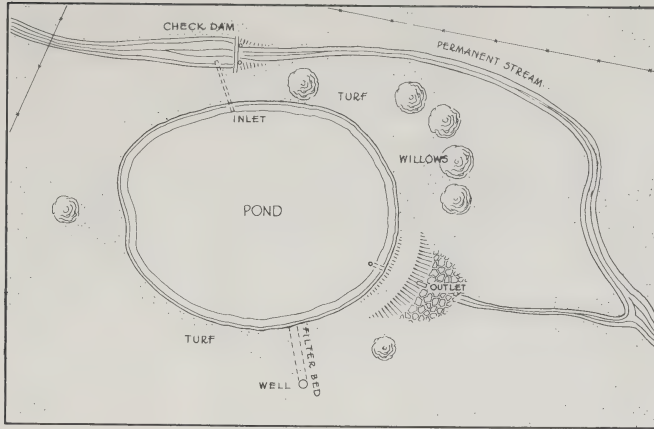
PLAN OF BY-PASS POND

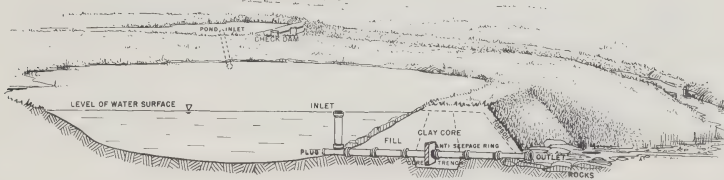
SECTION OF BY-PASS POND

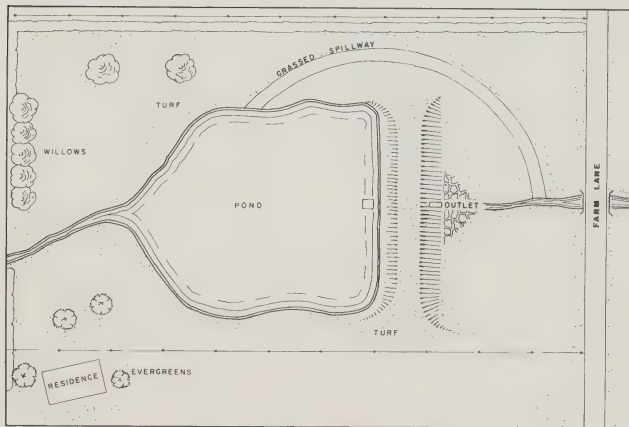
PLAN OF RUN-OFF POND

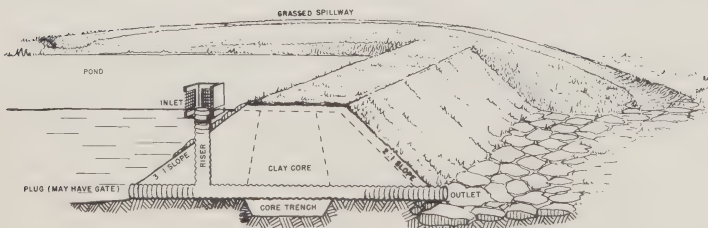
SECTION OF RUN-OFF POND

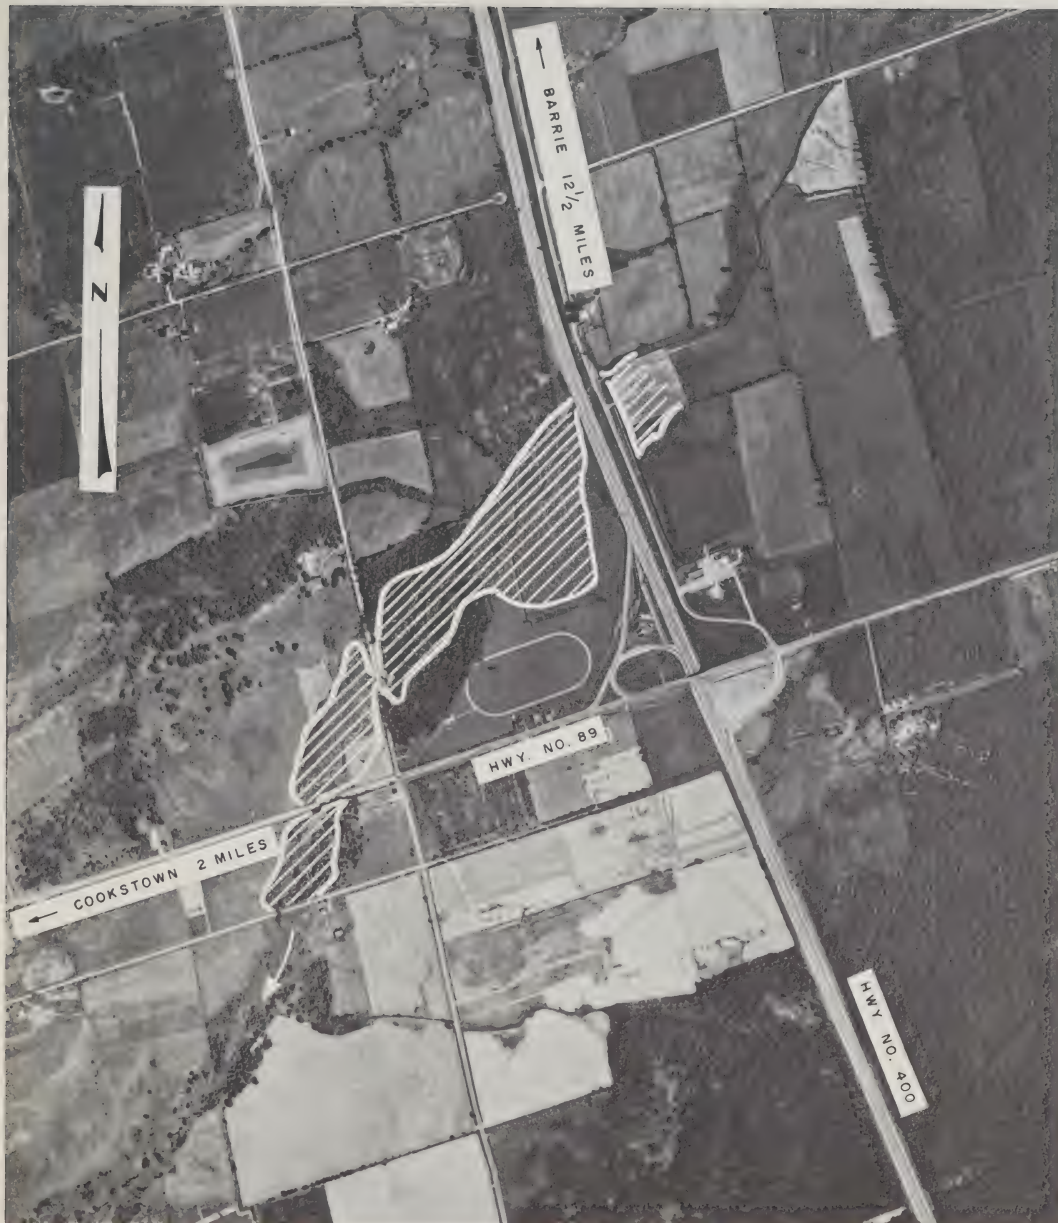
FIG. A-1

FLOOD PLAIN
OF
INNISFIL CREEK
(NEAR COOKSTOWN)

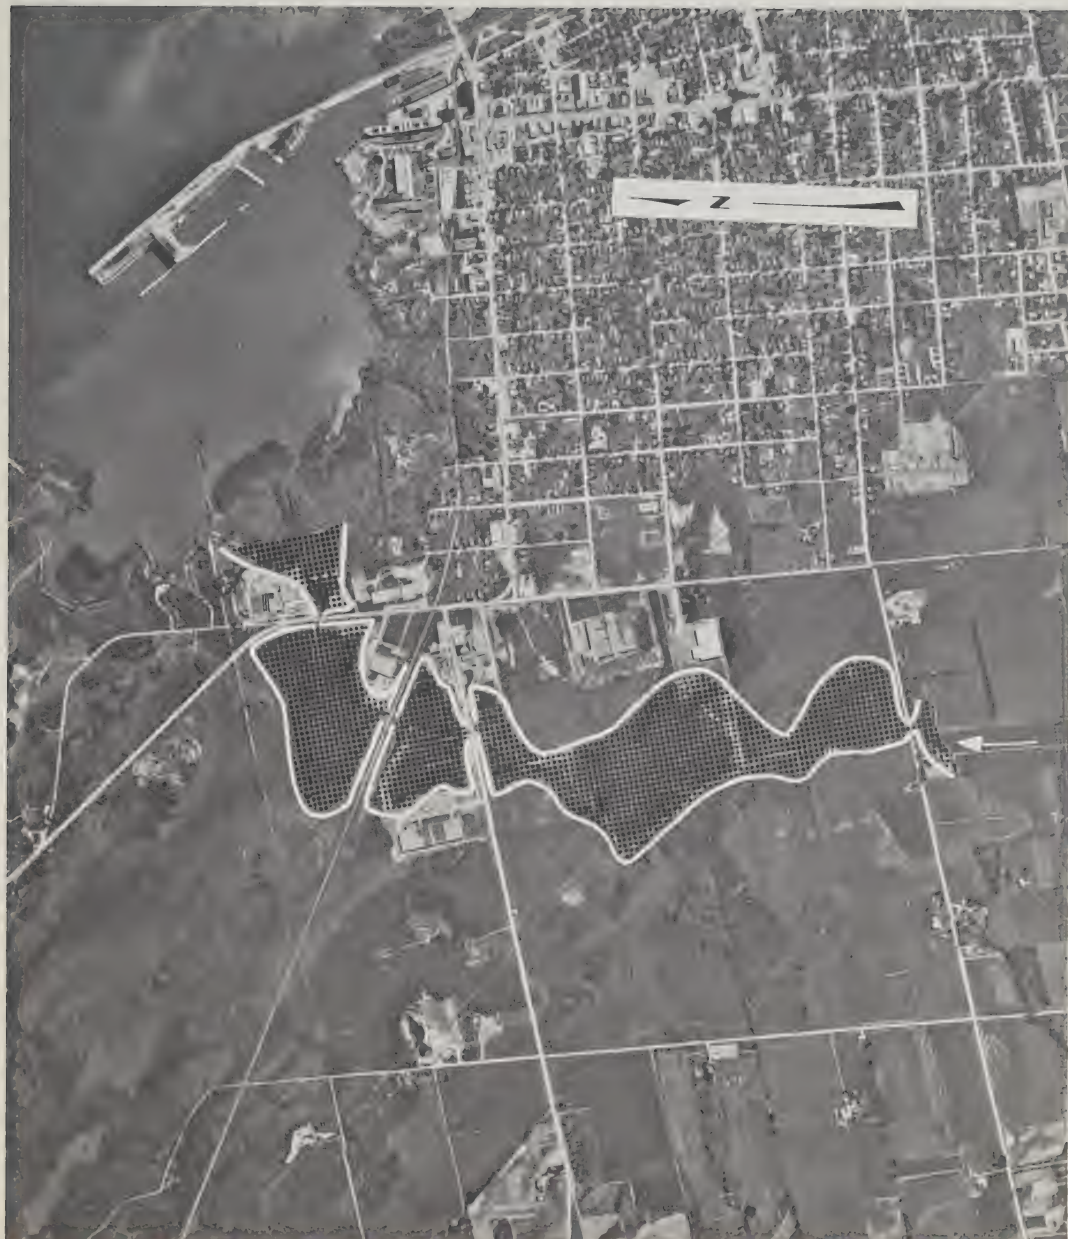
FIG. A-2

FLOOD PLAIN
OF THE
BLACK ASH CREEK
IN COLLINGWOOD

SCALE — 1" = 1320'
(APPROXIMATE)

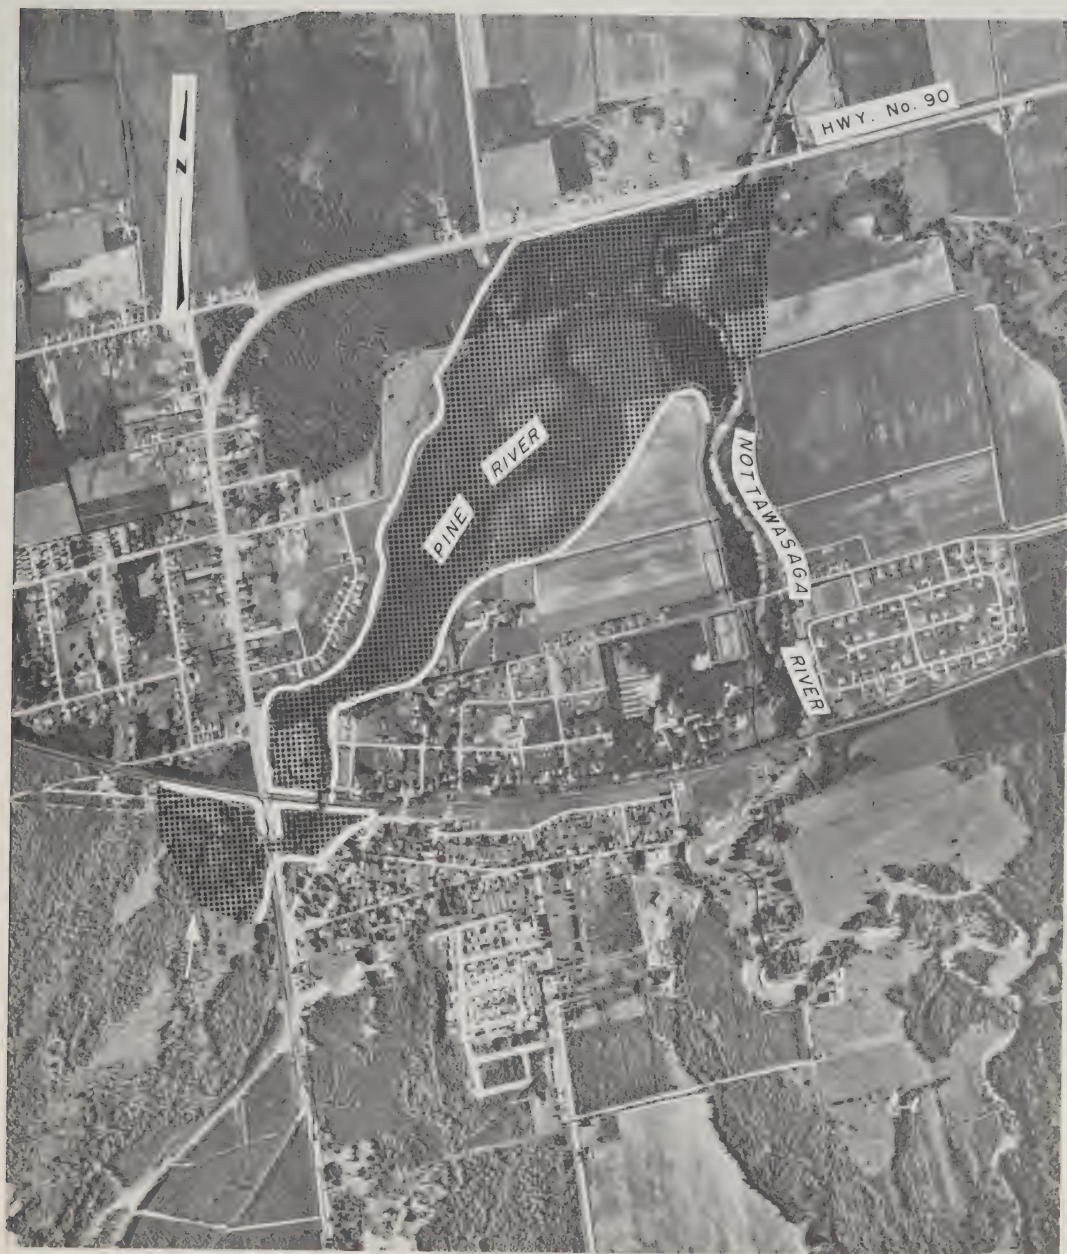
FIG. A-3

FLOOD PLAIN
OF THE
PINE RIVER
AT ANGUS

SCALE — 1" = 1320'
(APPROXIMATE)

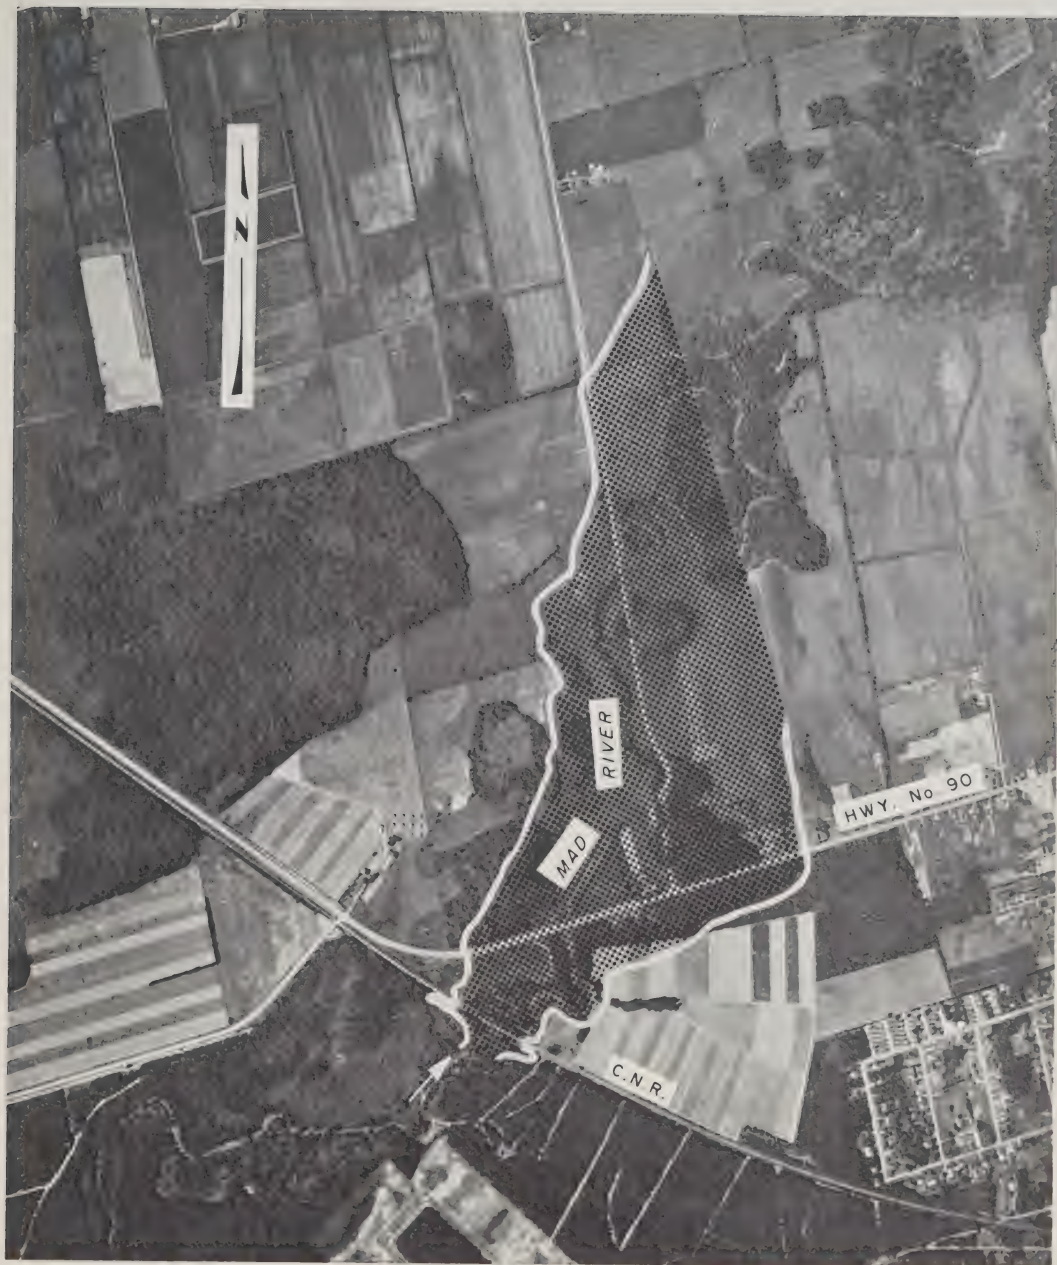
FLOOD PLAIN
OF THE
MAD RIVER
AT ANGUS

SCALE - 1" = 1320'
(APPROXIMATE)
